OFFICE OF THE INSPECTOR GENERAL CITY OF BALTIMORE

Investigative Report Synopsis

OIG Case #25-0011-I

On August 30, 2024, the Office of the Inspector General (OIG) received a complaint regarding unsafe and unsanitary work conditions at a Baltimore City Recreation and Parks (BCRP) office site located at 2100 Washington Boulevard, Baltimore, MD 21230.

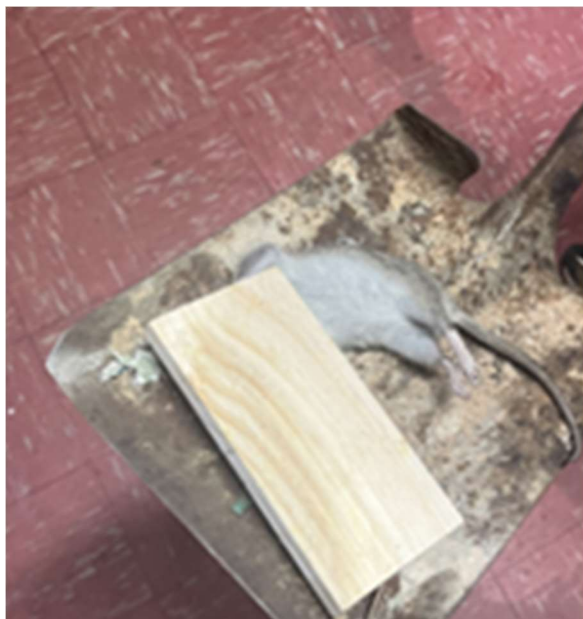
The OIG learned from employees that the facility has had an ongoing rodent infestation. The employees stated they do their best to clean the office and often sweep up rat droppings. The employee stated that the rodent issue was reported to the Department of General Services (DGS). The OIG obtained various photos of rodents previously captured by BCRP employees (Figures 3-6). The OIG reviewed metadata from the photos that appear to show when the pictures were taken.

Figure 3: Deceased Rodent (Metadata May 28, 2024)

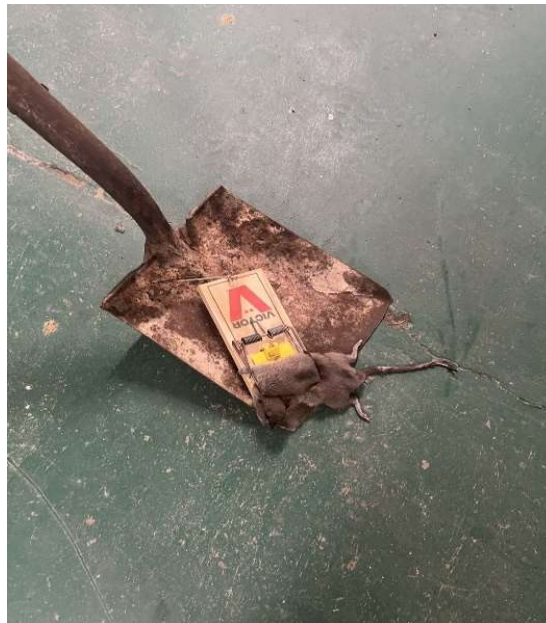
Figure 4: Deceased rodent (Metadata June 3, 2024)

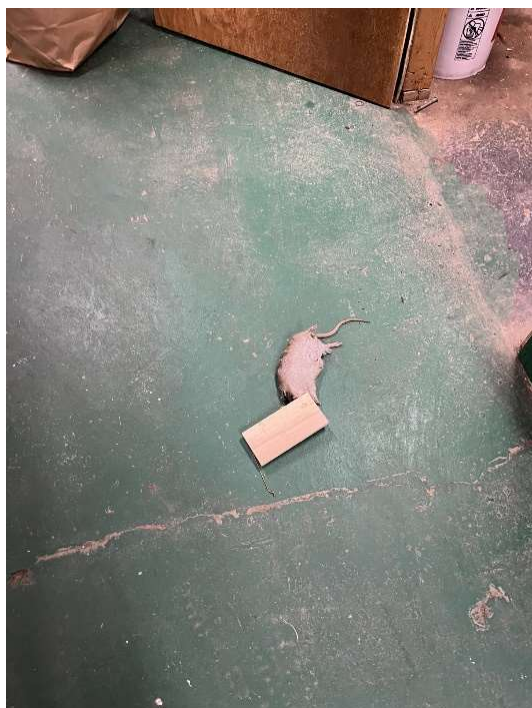
Figure 5: Deceased rodent (Metadata June 10, 2024)

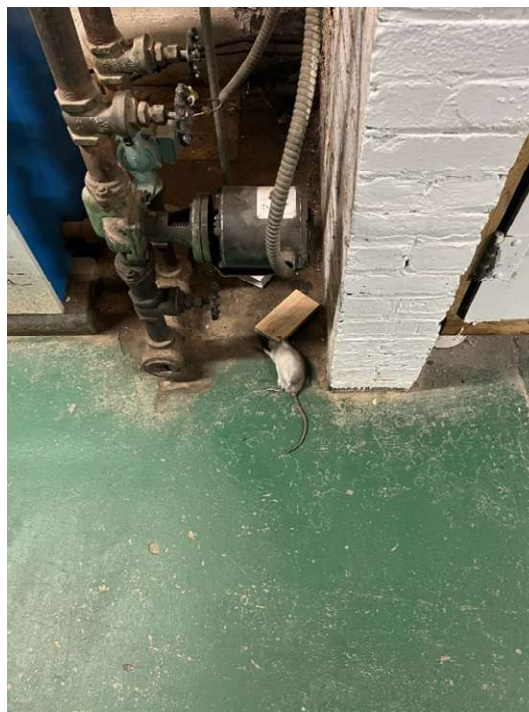
Figure 6: Deceased rodent (Metadata September 9, 2024)

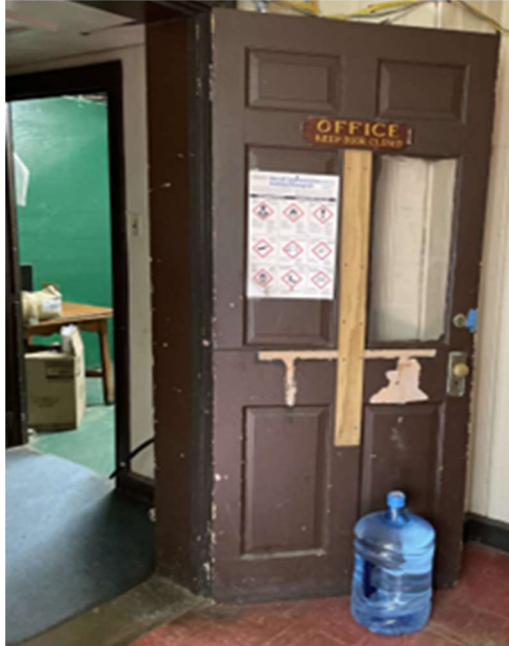
In the same printer room, the door to the staff break area was damaged (Figure 11). A windowpane appeared to be broken and repaired with black electrical tape (Figure 12).

Figure 11: Broken employee breakroom door panel

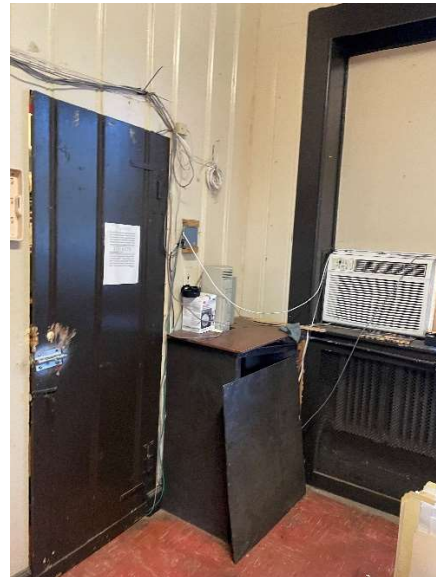
In an office area, the OIG noted partially exposed wiring where an air-conditioner was plugged in. An employee stated that the rats run through this area and chew the wiring (Figures 13-14). There were visible rodent droppings among the wires.

Figures 13&14: Exposed electrical wiring in the employee office

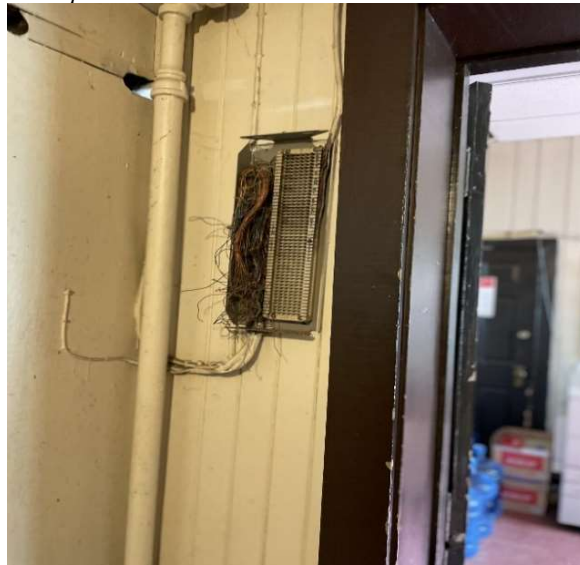
A wall panel outside an office door also had exposed wires (Figure 15).

Figures 15: Wall panel with exposed wires

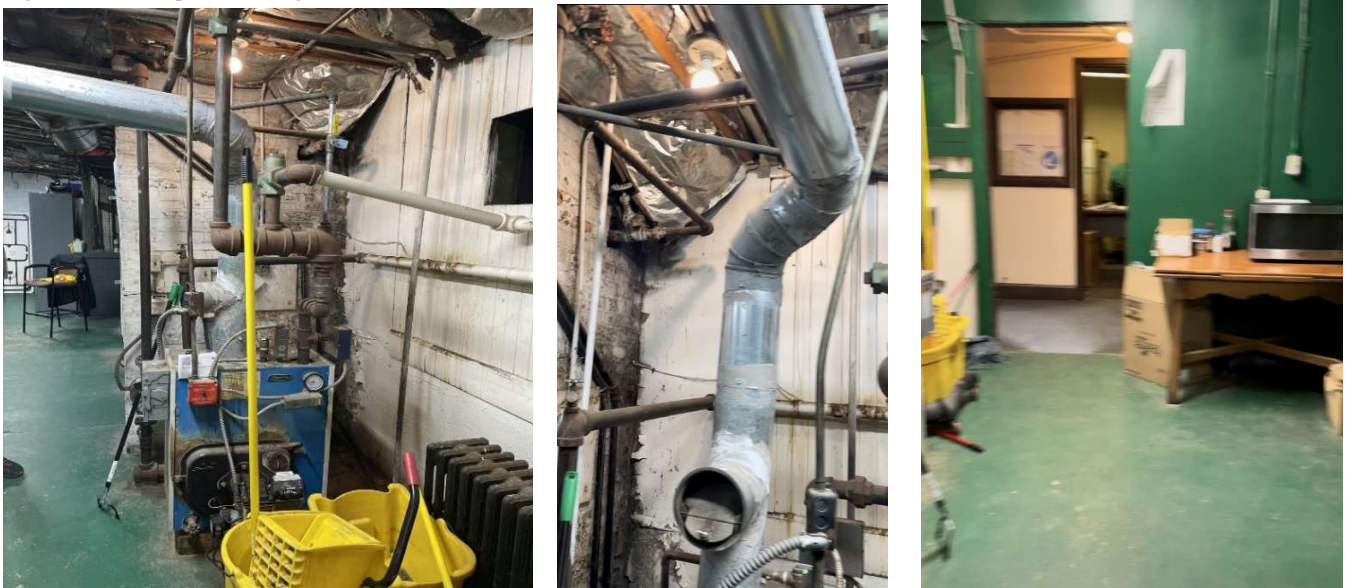
Exposed ceiling insulation was seen in the employee break area (Figures 16-18).

Figures 16-18: Exposed ceiling insulation in break room area

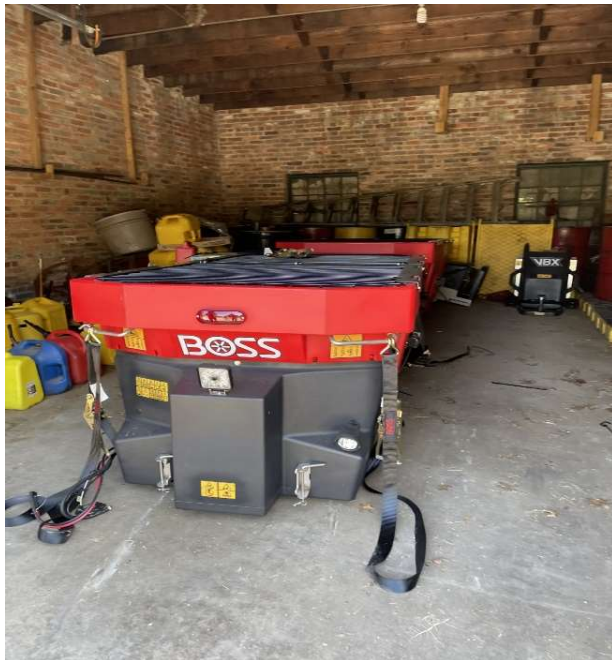
Equipment was stored in one garage that did not lock, potentially exposing it to theft (Figures 31-32).

Figures 31-32: Equipment inside of garage area (left), same garage area door without a lock (right)

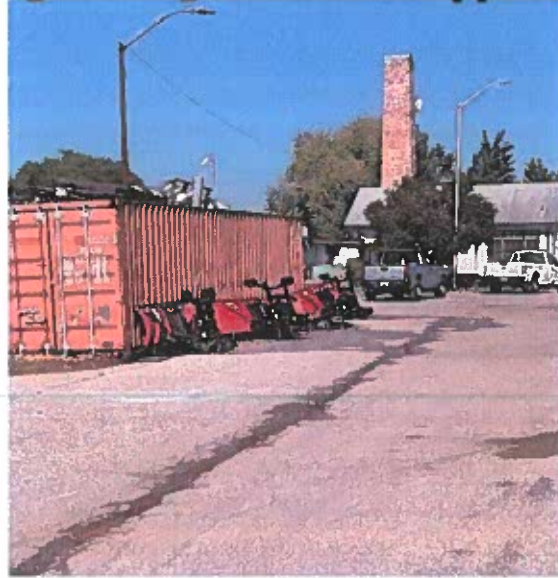
In another garage, ceiling damage and mildew odor was present (Figure 33). Snowplow materials were also stored in the open parking lot (Figure 34).

Figure 34: Parking lot with unsecured snow equipment
